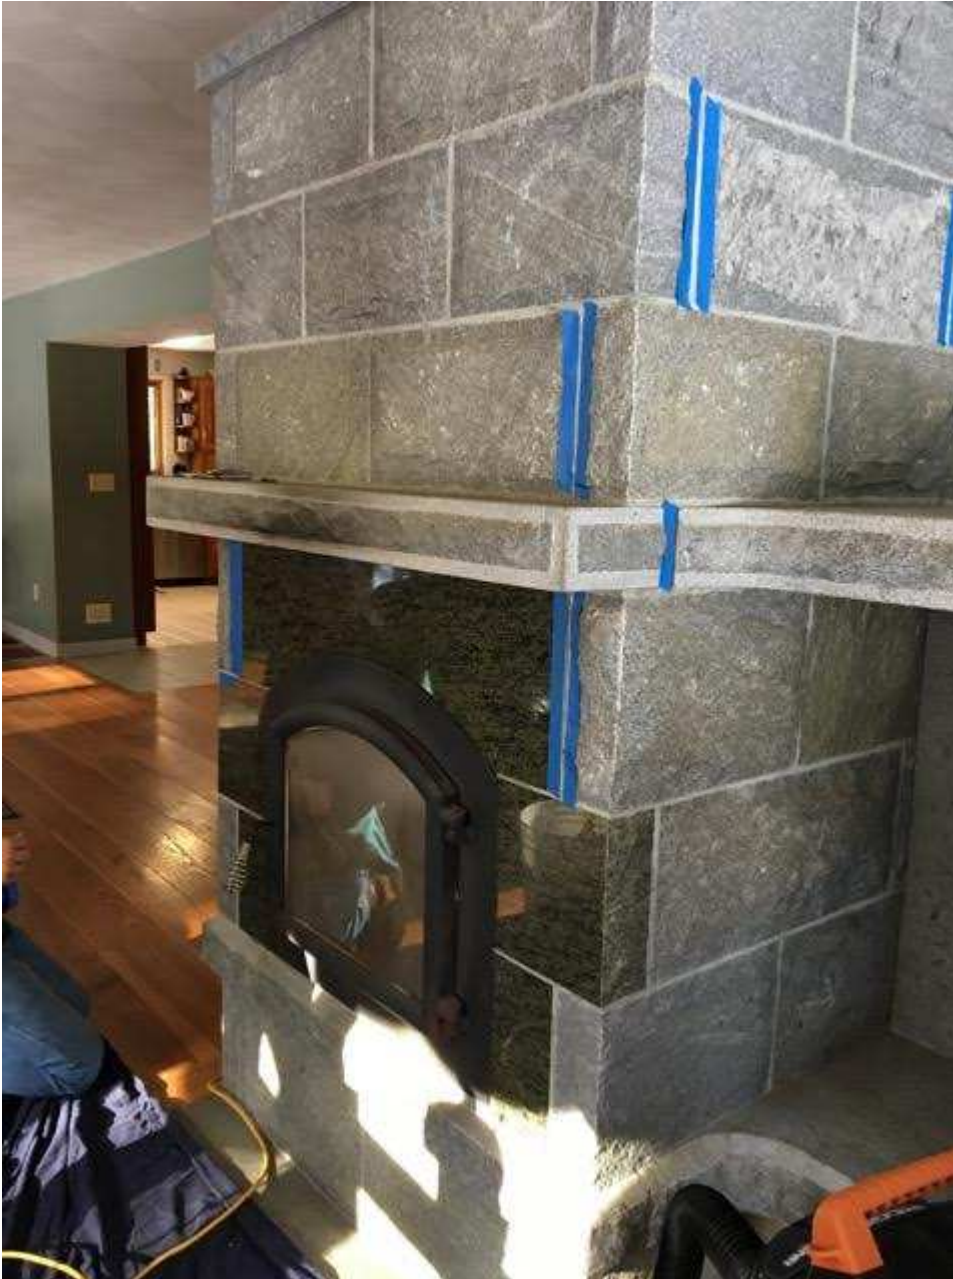
We taped the opened joints to easily identify them once we got going and act as a guide for a Bosch detail sander/grinder with a diamond masonry blade. I bought the tool after looking at pictures of the heater and it was a nice tool for the job. Dust was minimal. We didn't need to grind out all the mortar on the wider joints: just break the bond on the side that was still stuck to the stone

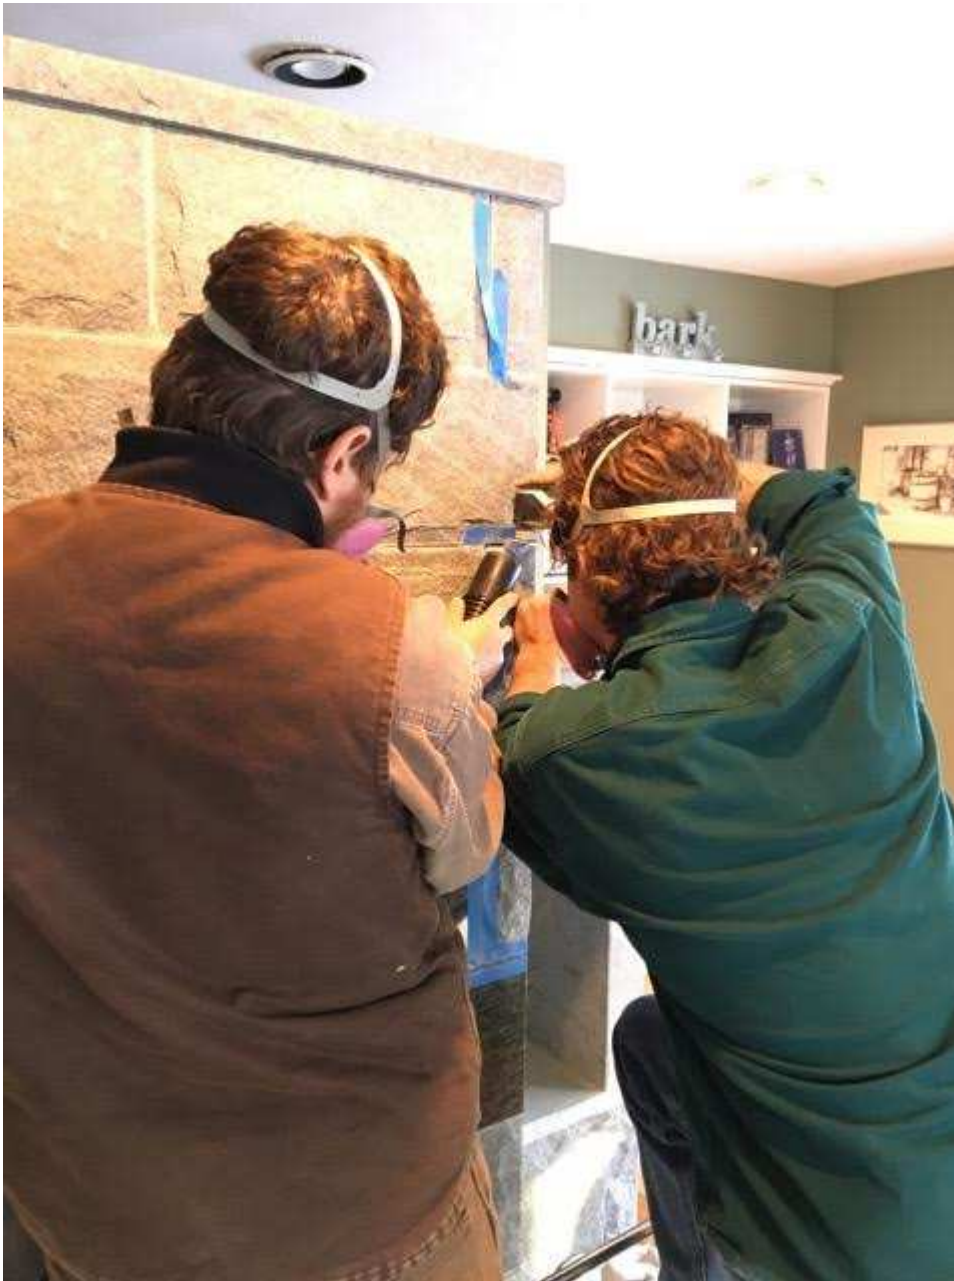
and gouge out the pieces.
Mason and his helper took turns with the vac and the grinder.

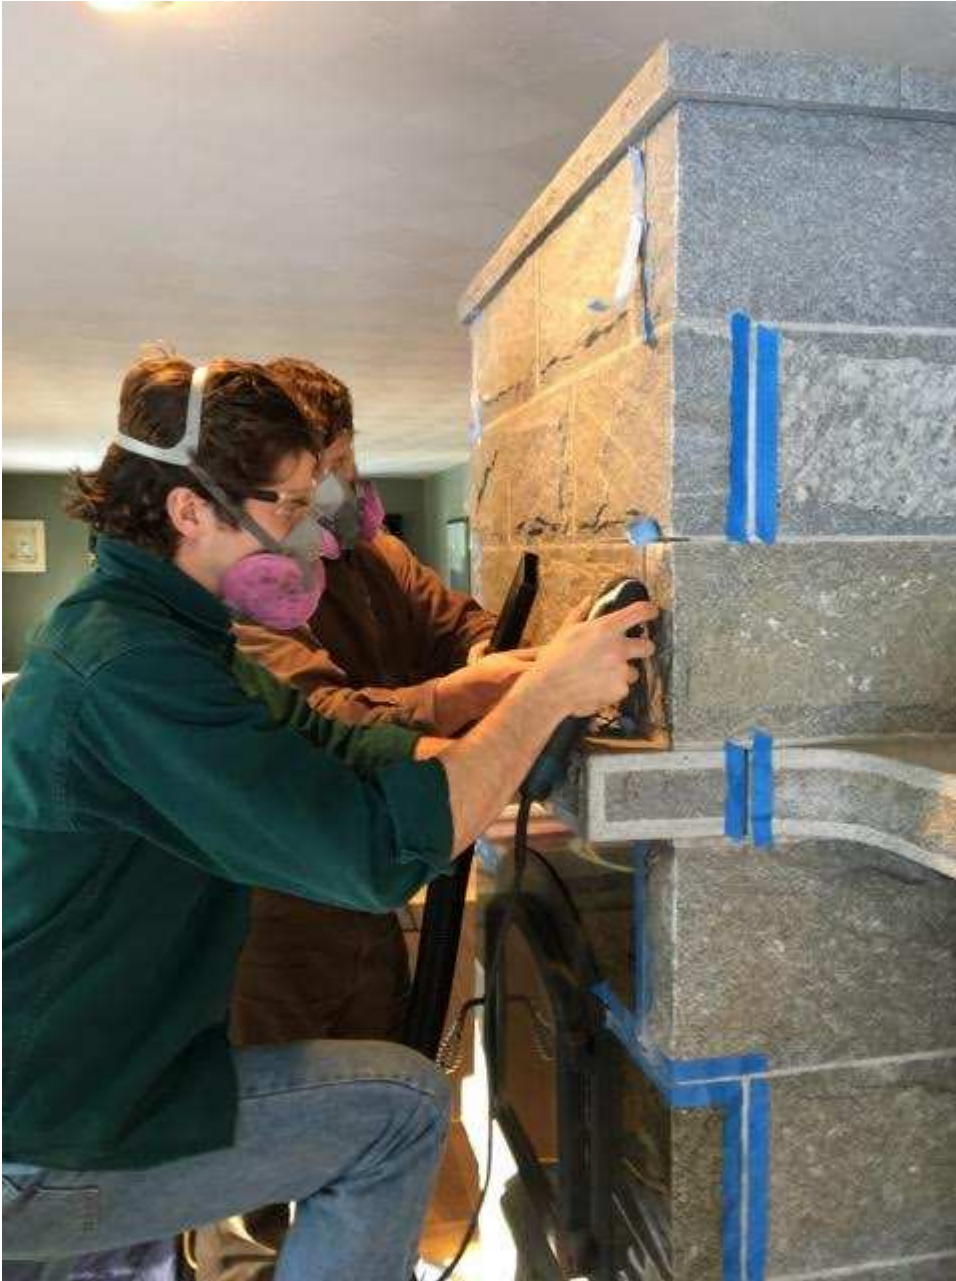
The tape also kept the stone clean during tuck pointing.

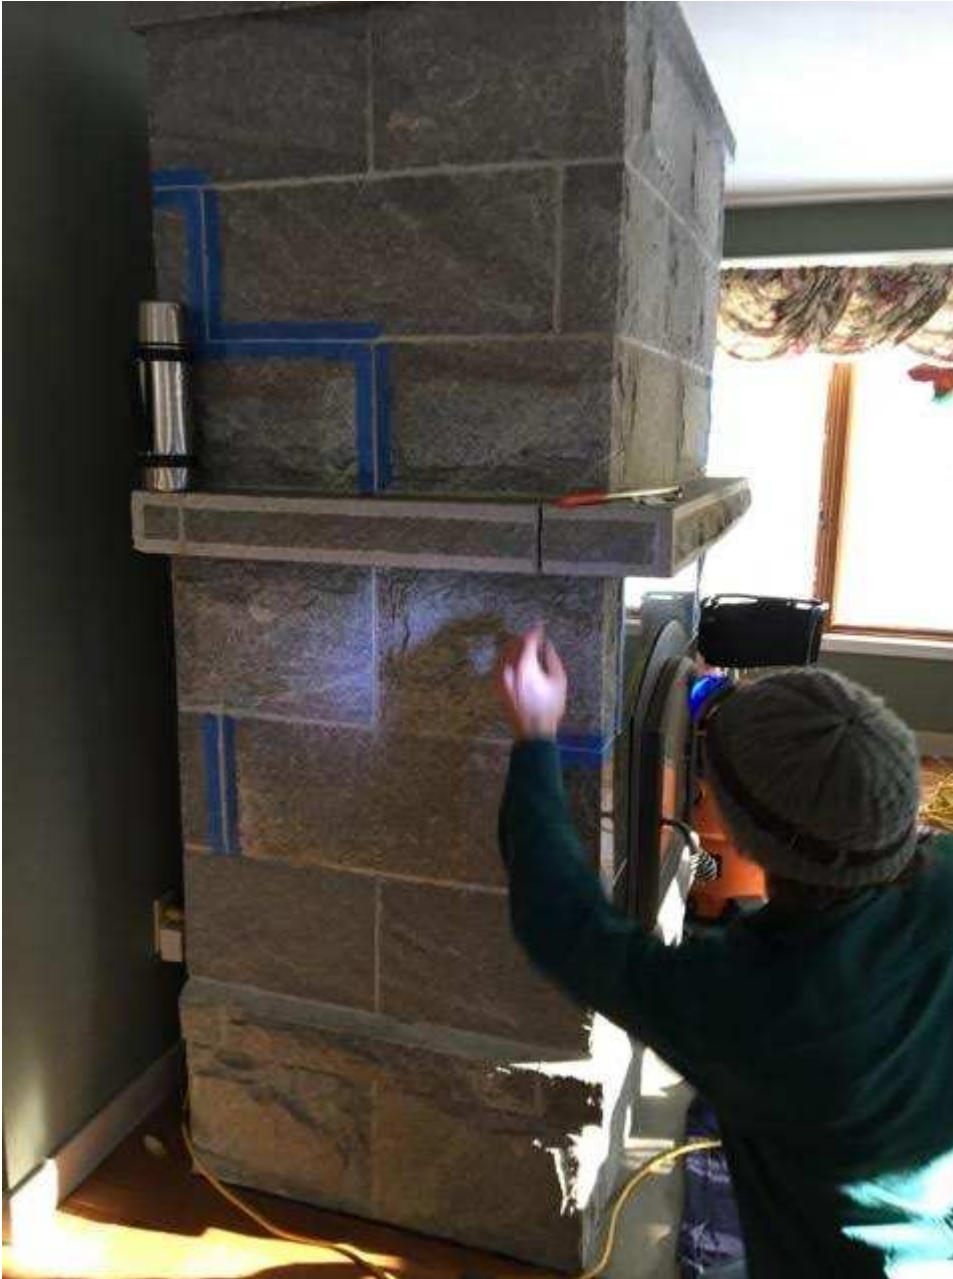
Other than the one on the right side of the door by Mason's knee and just above where he's working, the bed joint crack I mentioned earlier has been the only horizontal crack I've seen. And these are not from "lifting": they're from individual stones "sliding". My experience with expansion in the real world doesn't mirror what we might think it should be "in theory".
