Russian stove rebuilt
by Carl Oehme-stove mason and Guy Amyot-apprentice
“Hamm” heritage housebarn
Neubergthal, Mb.

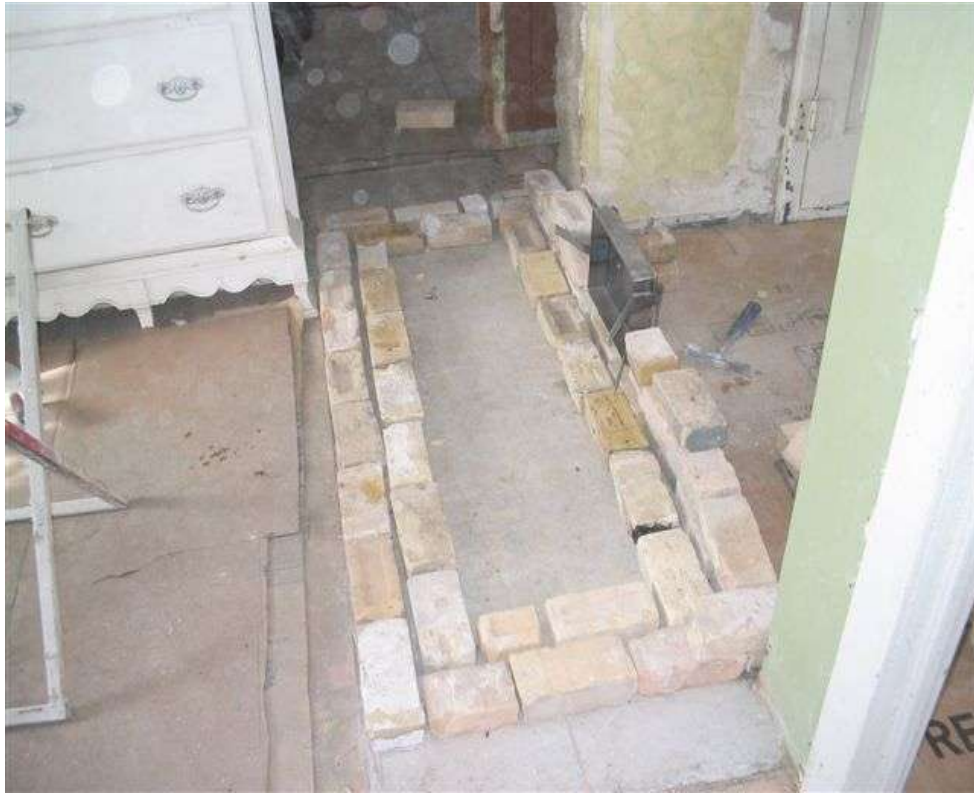
First course is laid out for an 8" reclaimed brick wall to support firebox floor. It's not immediately know what this area was used to store. An access door to this area was built into one side as per the original design. Close attention was given to the built in hutch (upper right in above photo)that originally touched the stove. Given that "campfire rules" now apply to the operation of the stove we still insisted that the stove not be allowed to touch any exposed wood surfaces. Hence the lay out meant moving the original stove's location slightly(1") and decreasing the overall length so that the wood partition wall (lower right in above photo)not touch the heater.

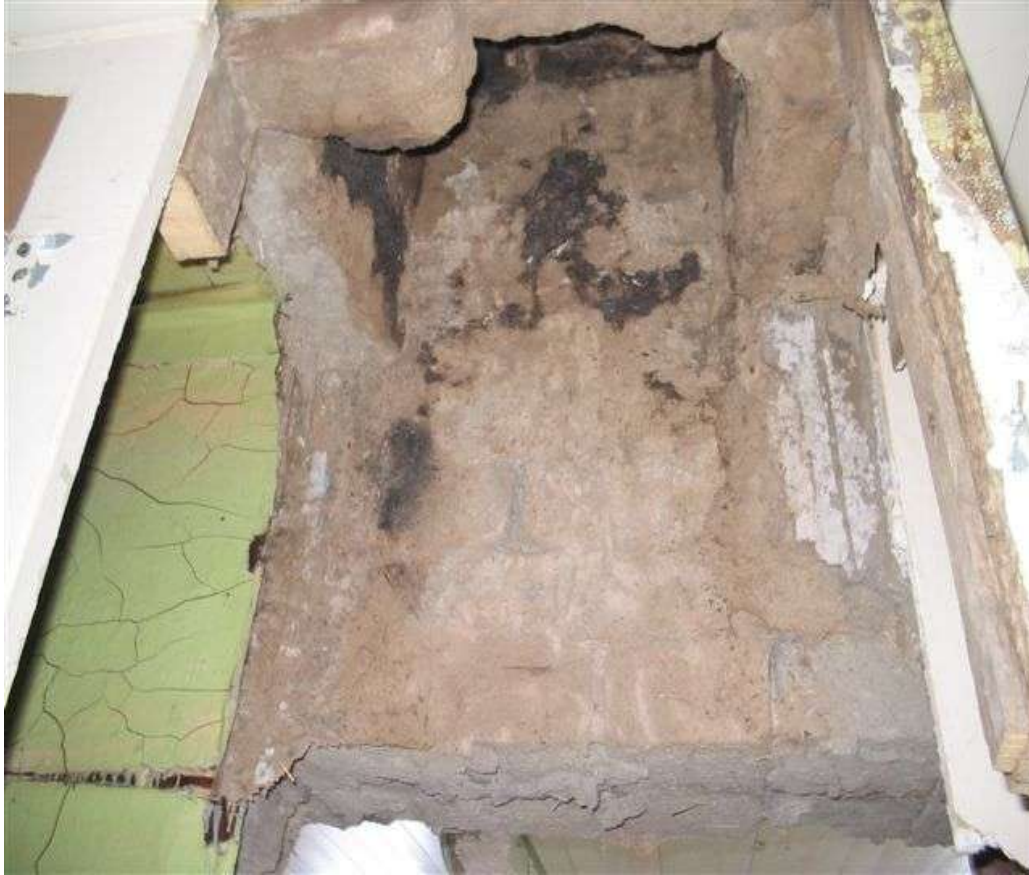
This photo taken from the kitchen up into the existing chimney shows the “manure sod” bricks that were used. The chimney portion of the sod had a clay coating which had stood up very well. Also note the proximity of a wood cupboard to the stove and chimney. This was removed to allow the stove to be moved over and will be rebuilt.

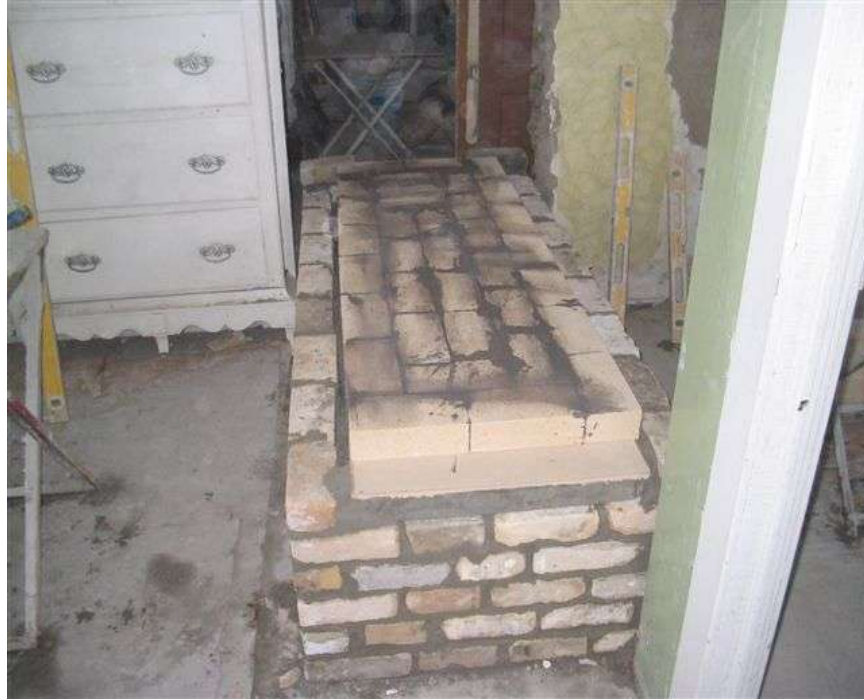
Stove is laid up to top of firebox floor. A precast concrete slab was poured for ease of installation by the contractor who didn't have access to any castable. We therefore placed a double layer of .25" non-asbestos millboard on top of the concrete slab before placing the firebrick floor.

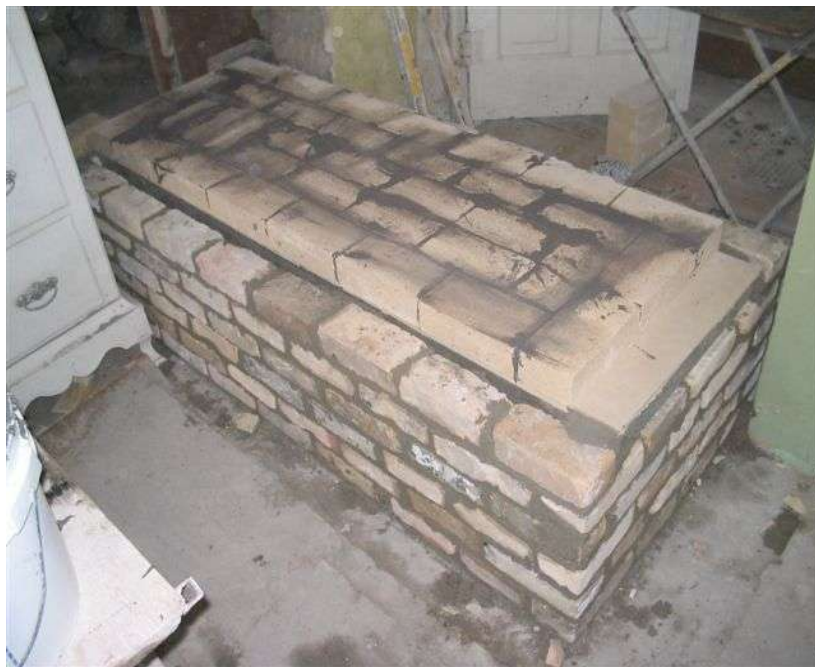
Another view.

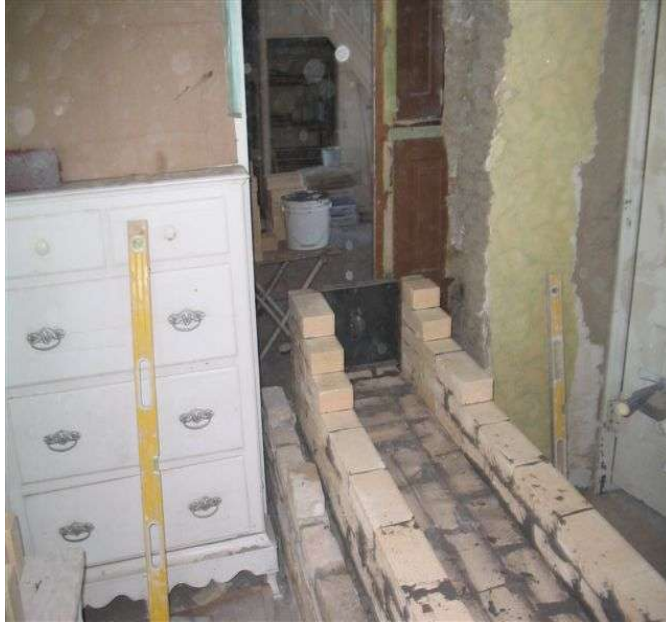
Firebox walls go up!

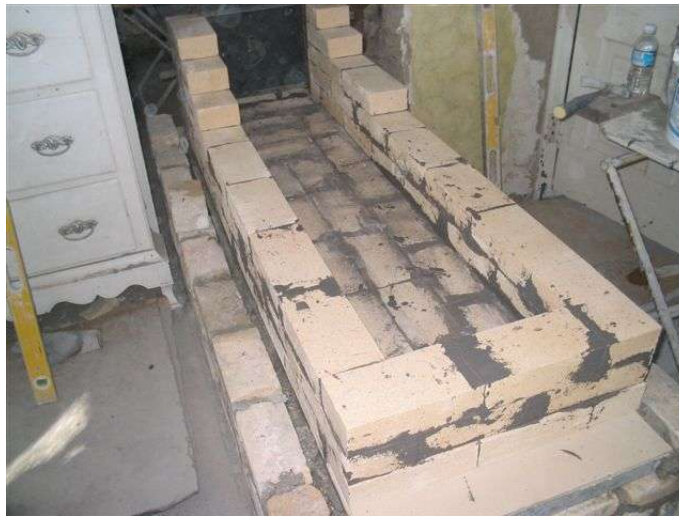
Another view.

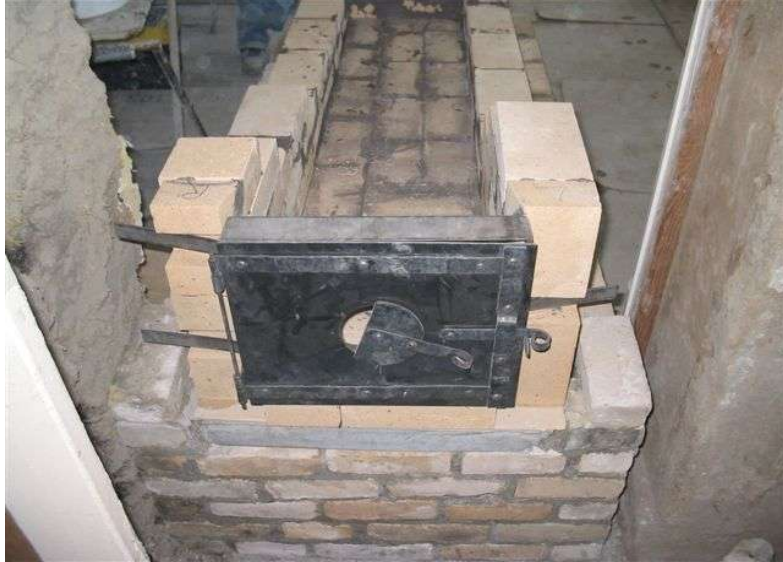
Additional views and from kitchen showing replica inner loading door.

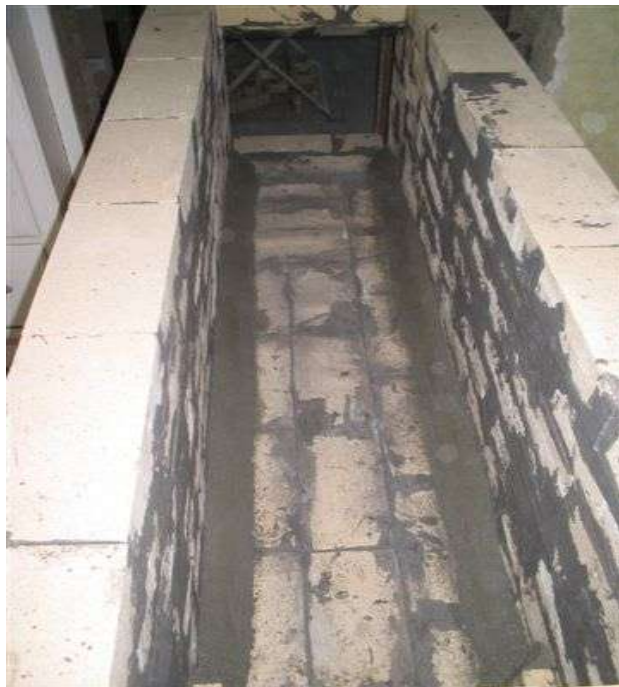
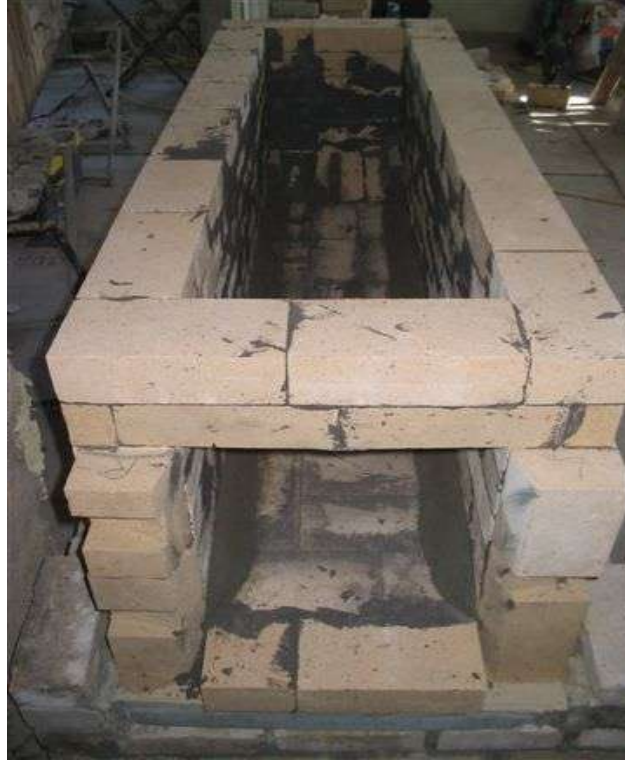
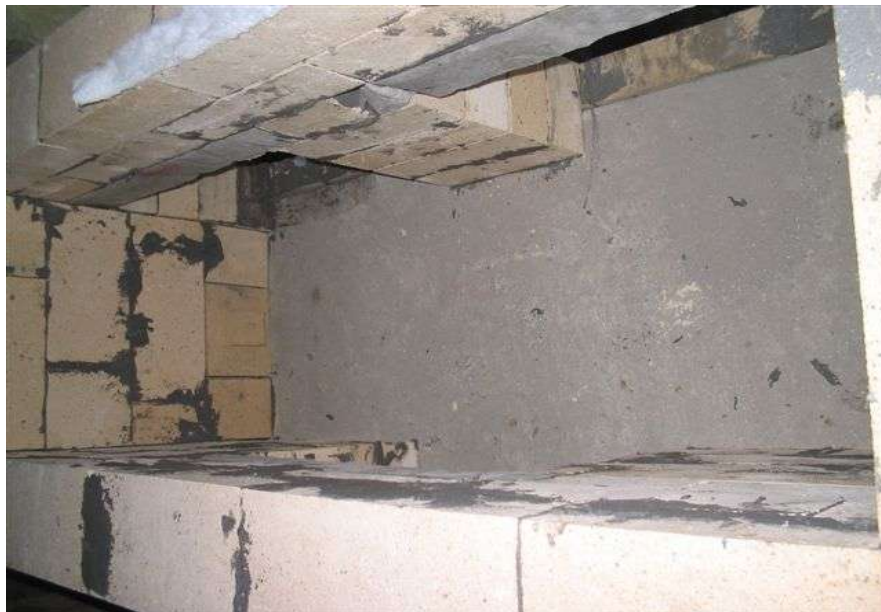
Firebox view before setting ceiling. We created a poured in place floor slope with castable since we felt the firebox being too narrow to accommodate a 45Deg. half firebrick. We did use firebrick cut at 45deg. At the far end of the firebox. Another view from front without loading door.

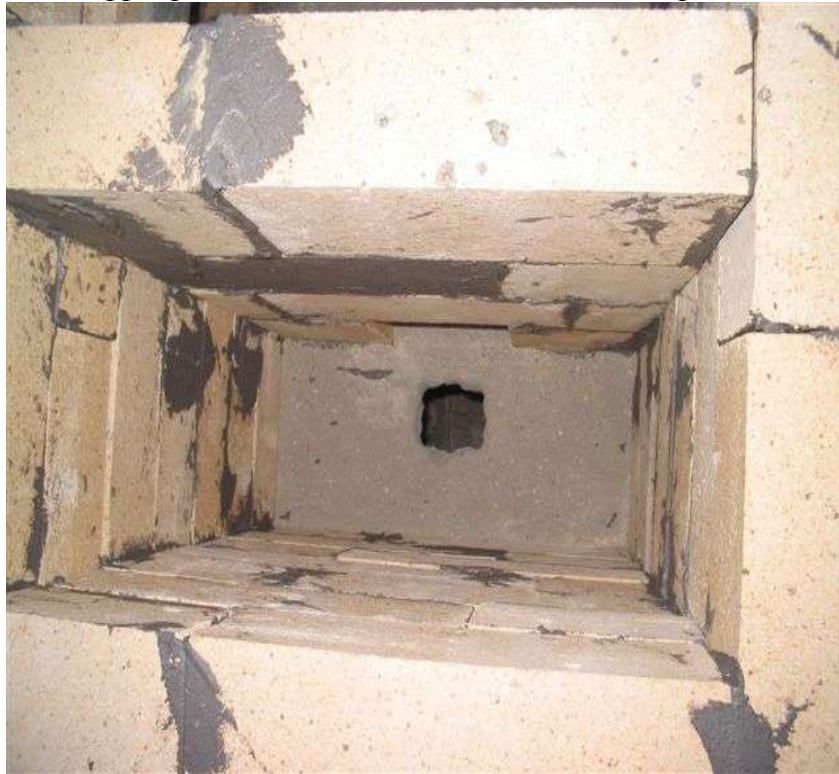
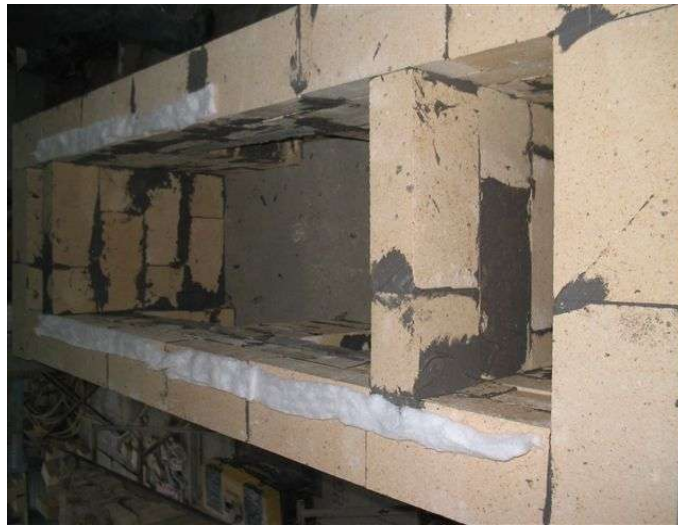
View of the baking and cooking area just above the firebox. There are 3 openings to this area. One is located on one side and two on the opposite side. The ceiling of the firebox floor which is also the floor of the bakeoven was precast the day we arrived using castable. We also precast the bakeoven ceiling and a two piece cap for the heater's top. Not part of the original design but felt it usefull we installed a 2" x 2" gas slot above the firebox which passes through the bakeoven exiting the upper channel. See below. Gas slot and warming chamber is seperated to the bakeoven. A clean-out plug cut from

firebrick was installed into this area from the bakeoven side. If you look carefully you'll see the plug in the upper photo at the floor on the left side of the photo.

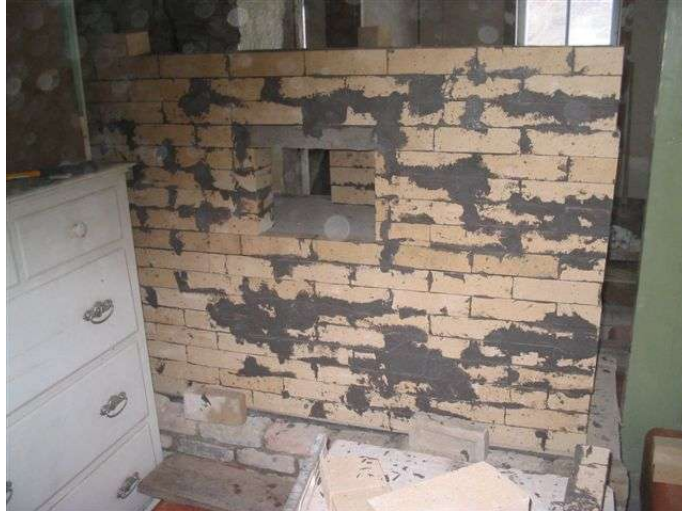
Mineral wool was used before installing all the precast pieces.

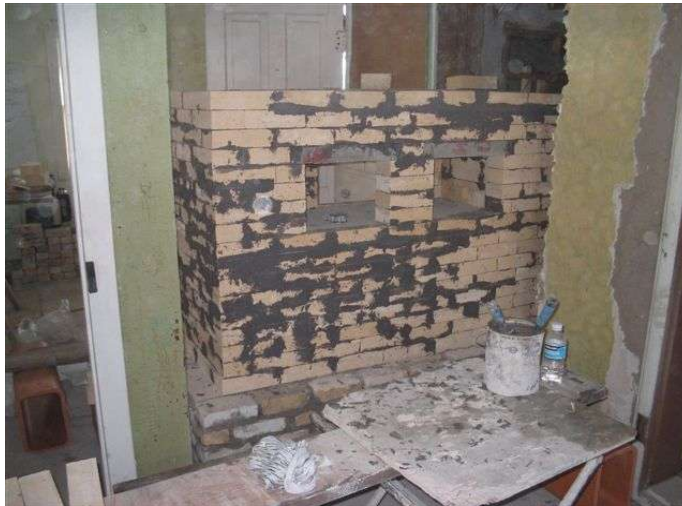
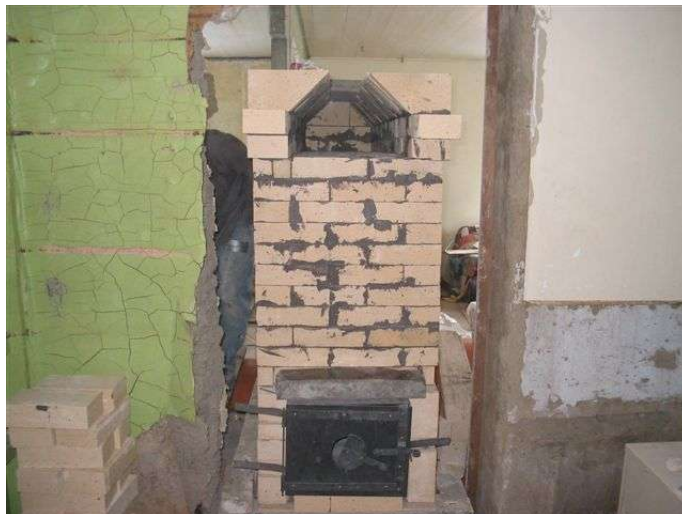
Precast castable lintels were made for all firebox and bakeoven doors.

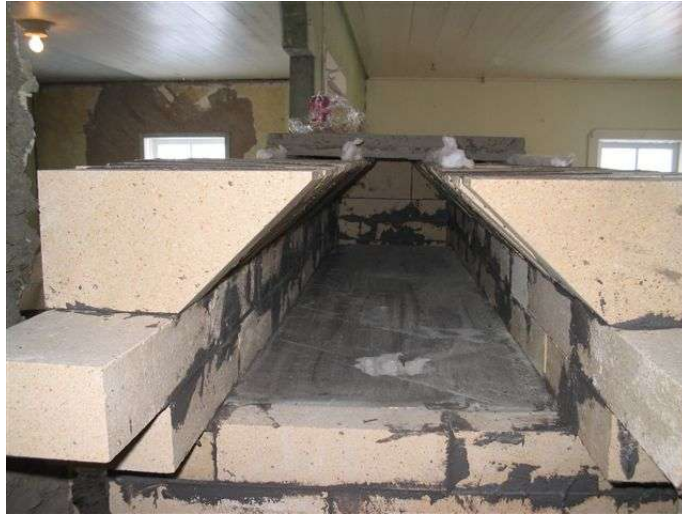
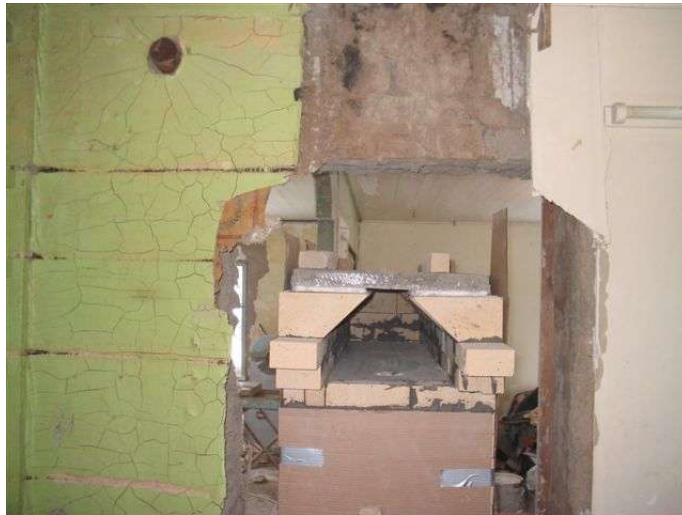
We tapered the top of the upper channel to allow a more streamlined gas flow and complete combustion. The top of the heater was often used as a place to bed sick

children or infants so we wanted to ensure this area absorbed as much heat as possible.

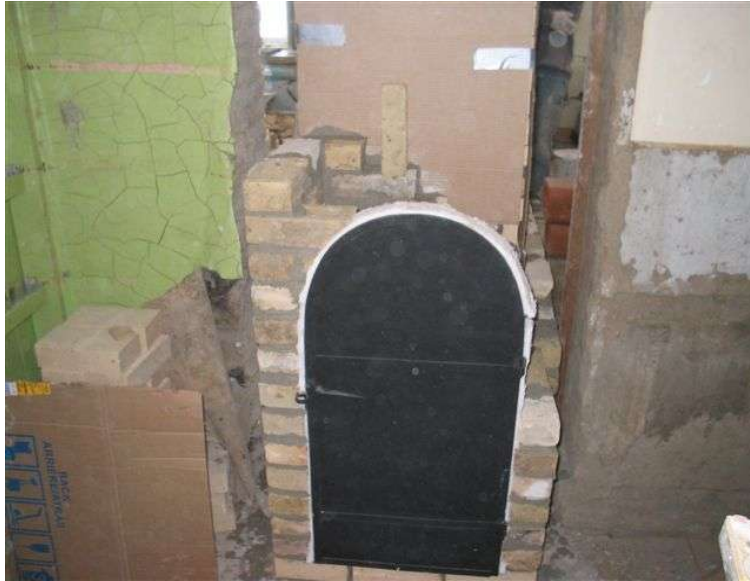
The above shows capping slab installed and cardboard spacers used as a slip joint between the heater's core and the facing.

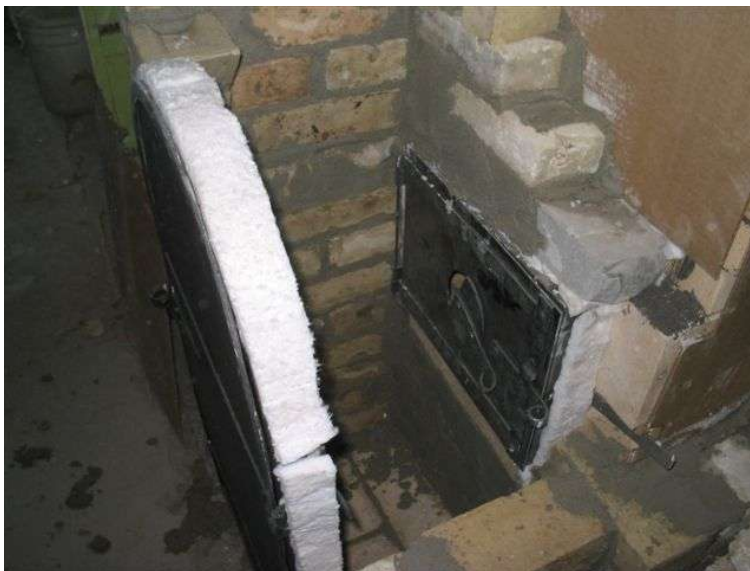
Original outer door being installed. It had 2 welded “handles” on either side that were mortared into the brickwork. This outer area had no other protection save for a single wyth of clay brick that was parged both inside and out.

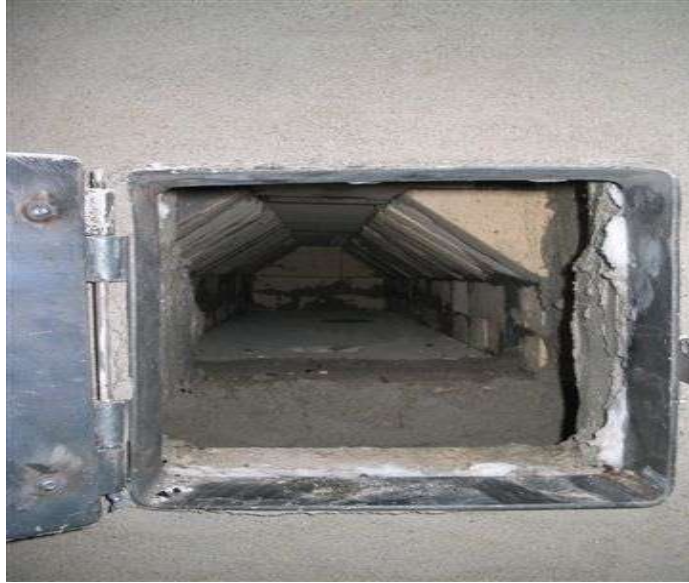
Space between the outer door and the inner firebox loading door.

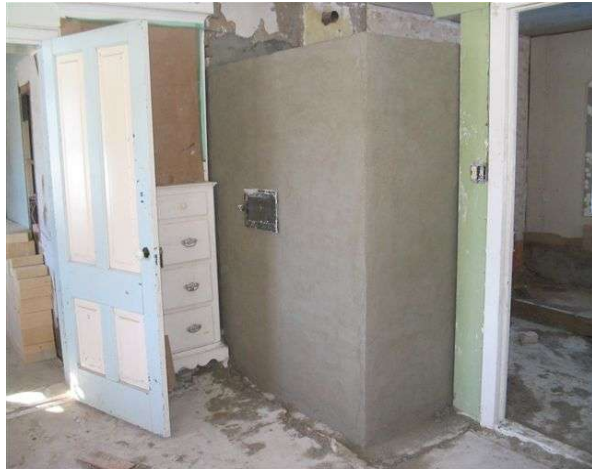
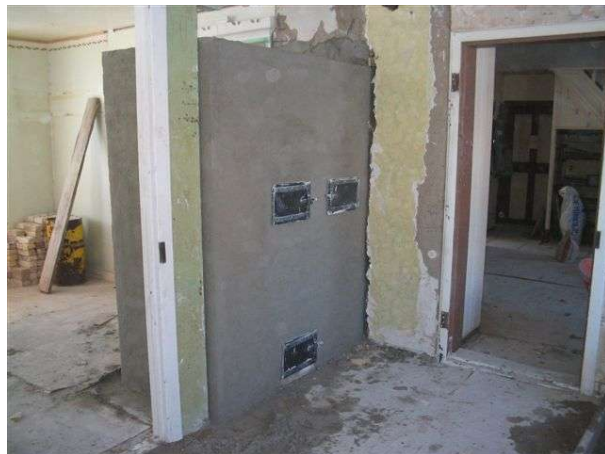
We gave a coat of mortar to the entire surface before a final coat of horse manure plaster which will be added afterwards. The above shows a view through an upper channel clean-out door.
